SUSQUEHANNA RIVER BASIN  
**ALEXANDER LAKE DAM**

TIOGA COUNTY, NEW YORK  
INVENTORY NO. N.Y. 936

NEW YORK DISTRICT CORPS OF ENGINEERS  
JULY 1981

REPORT DOCUMENTATION PAGE		READ INSTRUCTIONS BEFORE COMPLETING FORM
1. REPORT NUMBER	2. GOVT ACCESSION NO.	3. RECIPIENT'S CATALOG NUMBER
AD-A109782		
4. TITLE (and Subtitle) Phase I Inspection Report Alexander Lake Dam Seneca River Basin, Tioga County, NY Inventory No. 839		5. TYPE OF REPORT & PERIOD COVERED Phase I Inspection Report National Dam Safety Program

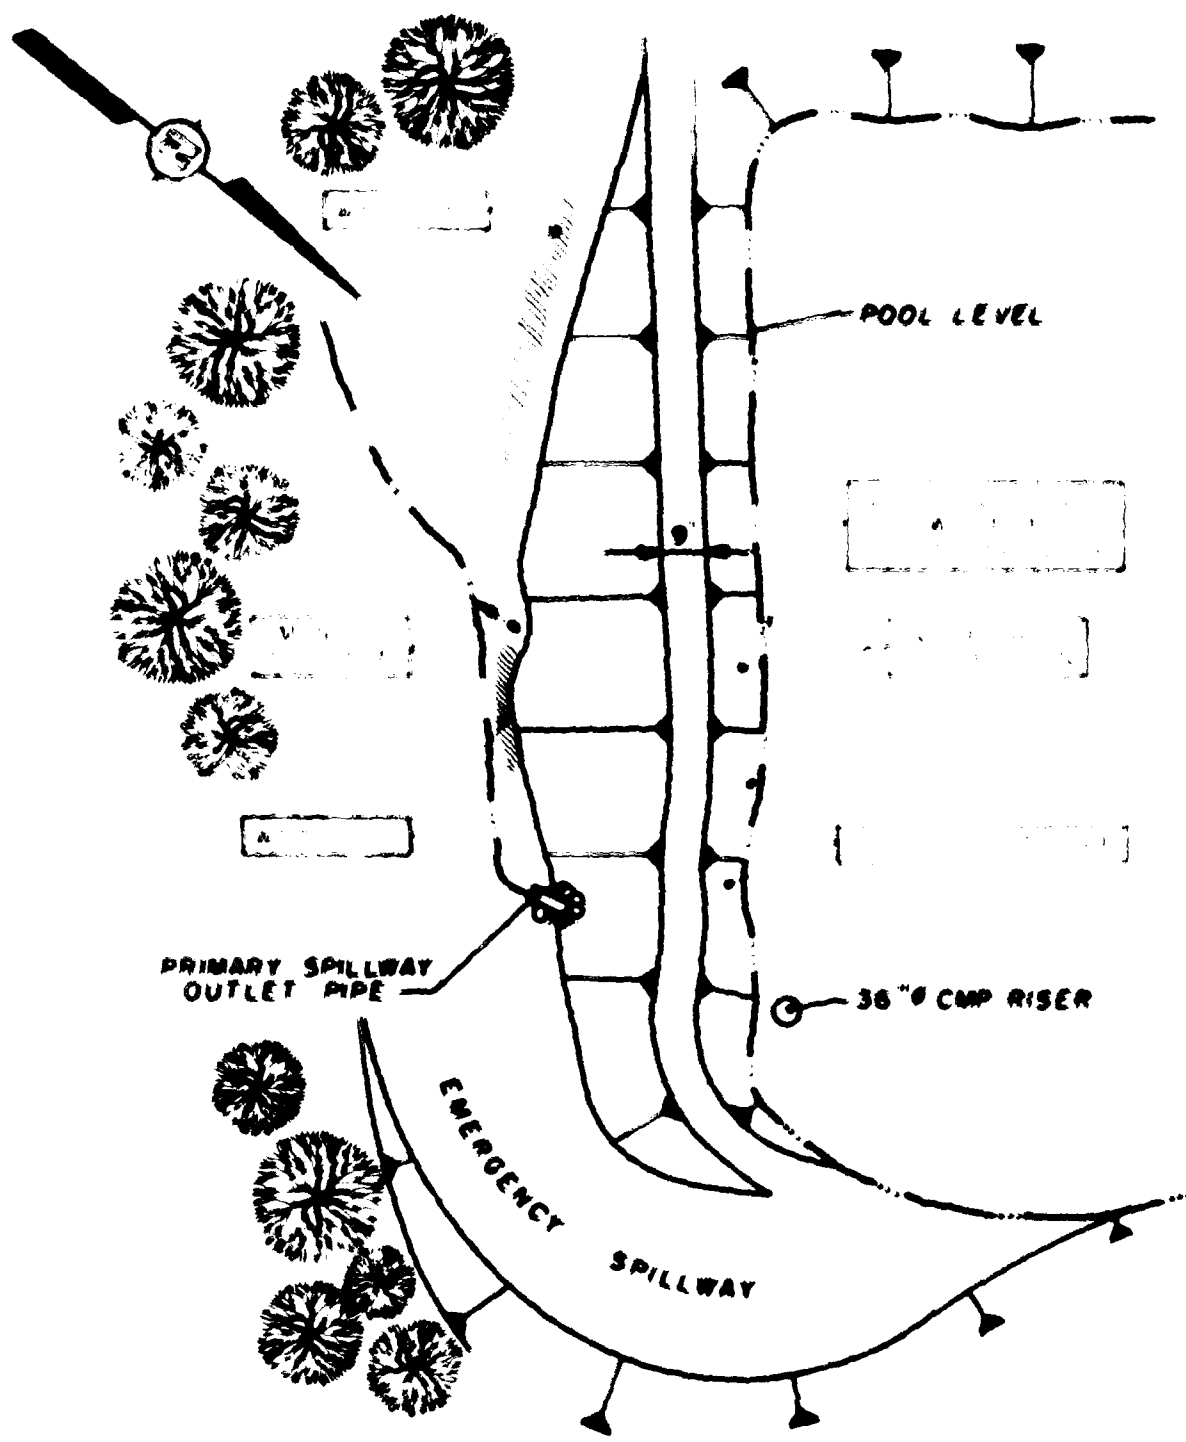
**PLATE 5**  
 ALEXANDER LAKE DAM  
 GENERAL PLAN  
 FIELD INSPECTION NOTES  
 FIELD INSPECTION DATE: MAR. 27, 1981

In general, the condition of the dam is considered to be fair. Field observations are illustrated in Plate 5. Two wet areas were observed along the downstream toe of the dam. No seepage flow appeared to be associated with the wet areas. A minor seepage was located on the downstream toe in an area which appeared to be the discharge channel of the low level outlet facility. The upstream slope shoreline was found to be irregular and lacked erosion protection. However, no significant erosion due to wave action was noted.

**NOTE**  
 POOL LEVEL AT DATE OF  
 INSPECTION PRIMARY  
 SPILLWAY CREST
